Accessibility Audit

Holy Trinity Catholic School

Oakley Road
Small Heath
Birmingham
B10 0AX

13/07/2022

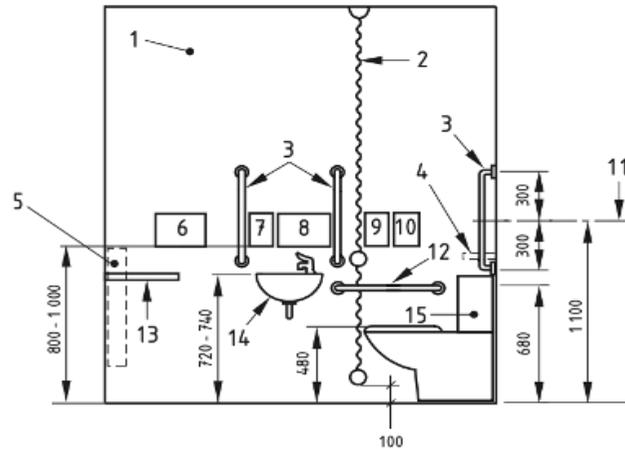
13.5
Cont.

A grab rail was missing to the left of the transfer grab rail in the St Chads facility.

No contrast was provided to the grab rail set near to ICT support and a grab rail was missing to the left of the mirror.

Height of drop-down support rails to be the same as the other horizontal grab rails.

The grab rail set should be replaced or improved with a new BS8300 compliant set that offers colour contrast.

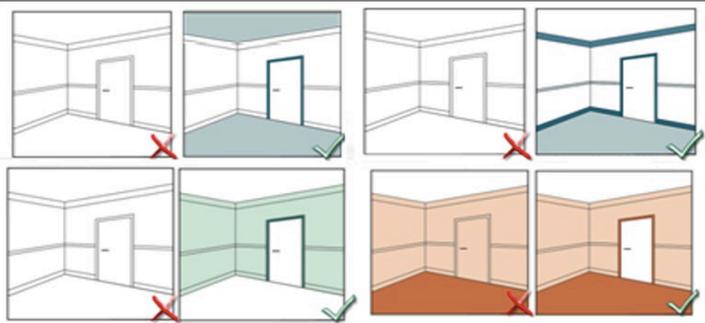
8.1	<p>A variety of door colours were provided across the school, many of which were suitably contrasted.</p> <p>The Chapel door was white against a white frame. The doors along the corridor towards the Art and IT classrooms were wooden against wooden frames. These doors may not sufficiently contrast their surroundings.</p>	<p>Ideally all doors should have contrast against the surroundings upon which they are seen. This could be achieved by painting the door frames a contrasting colour. Adding colour contrast will aid people with impaired vision.</p>
