Accessibility Audit

Holy Trinity Catholic School

Oakley Road
Small Heath
Birmingham
B10 0AX

13/07/2022

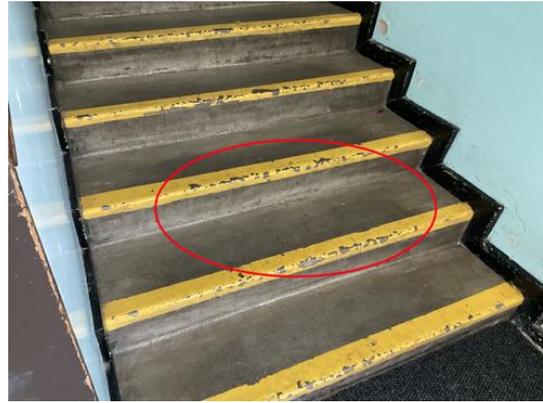
Photo 211

Many of the steps and stairwells across the school featured suitably contrasted nosings. The nosings near to the Chapel in St Chads require repainting as they were beginning to fade. There are damaged nosings on the stairwells leading towards Science. Nosings were not provided to the steps in the admin building.

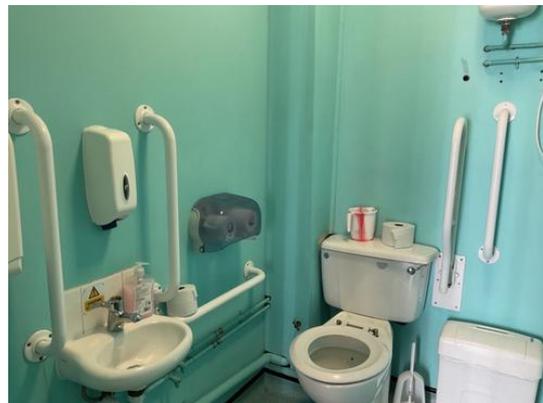
Photo 341

A grab rail was missing to the left of the transfer grab rail in the St Chads facility.

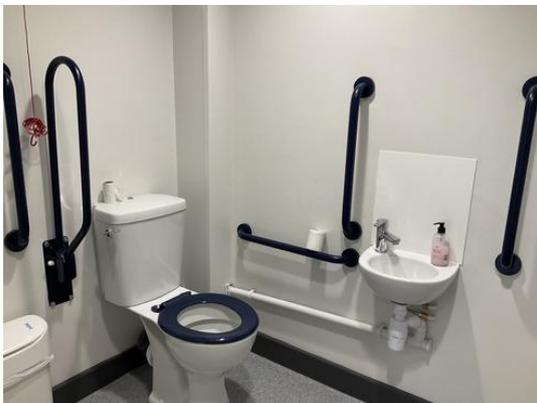
Photo 342

No contrast was provided to the grab rail set near to ICT support and a grab rail was missing to the left of the mirror.

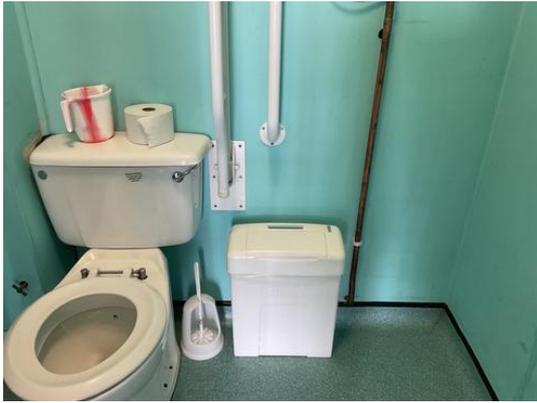
Photo 354

The flush in the St Chads facility was broken on the day of the survey.

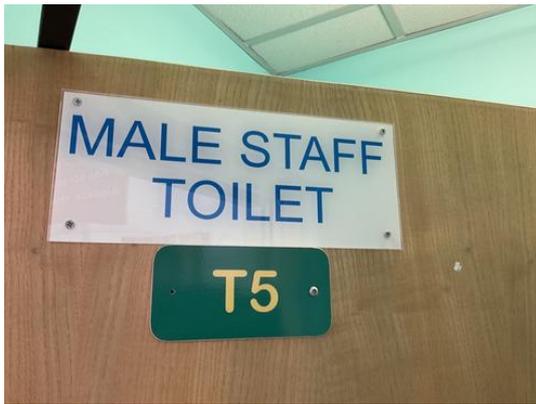
Photo 418

Some notice boards featured reflective, protective coverings, which could cause confusion for people with impaired vision.

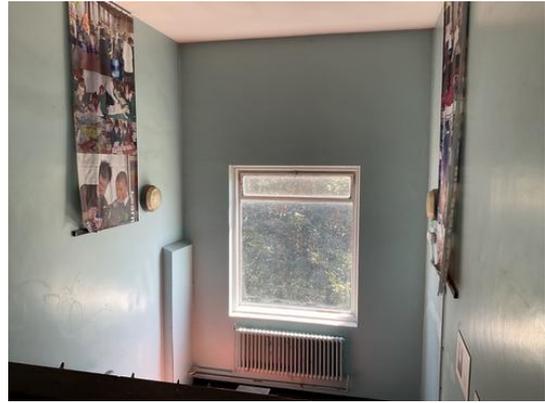
Photo 435

Wall lighting was identified on the stairwells in the St Chads building. Wall lighting can cause glare for people with impaired vision.
